Submission of the  
Asiana Pilot Union  
to the  
National Transportation Safety Board  
Regarding the Accident Involving

Asiana Flight 214  
B777-200ER  
DCA13MA120  
San Francisco, CA  
July 6, 2013

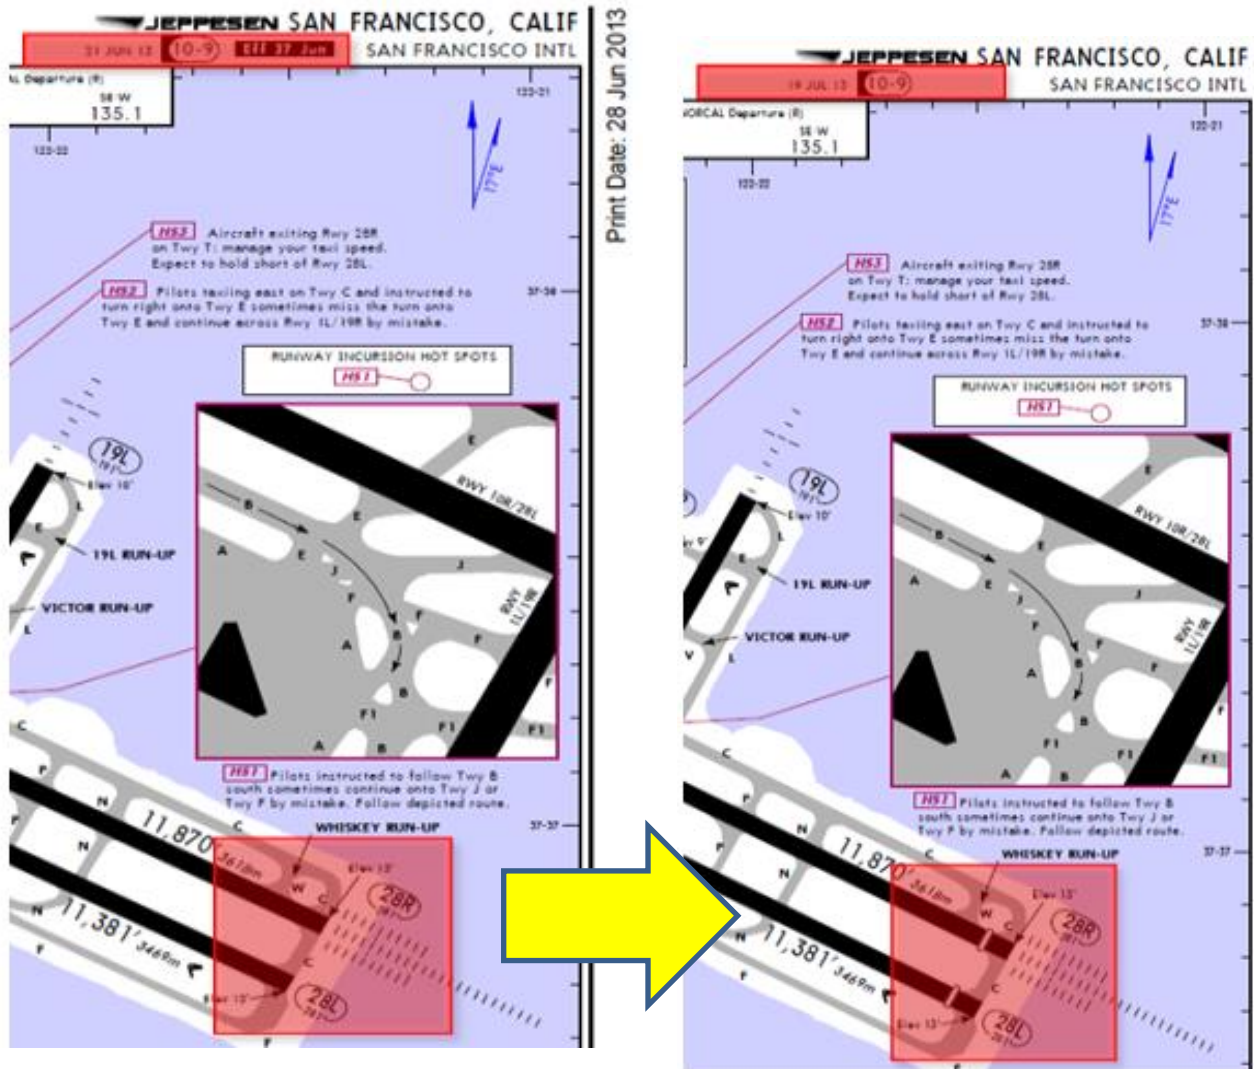
Figure 1 - Jeppesen Chart

SFO has been undergoing construction on its runways from July 2012. Latest development as a result of construction work is that the LDA (landing distance available) had changed and a displaced threshold of 300 feet had been put in place. This new information was not adequately disseminated to pilots in the Jeppesen Chart in a timely manner. Was a revised AIP issued on this change. (See Figure1)

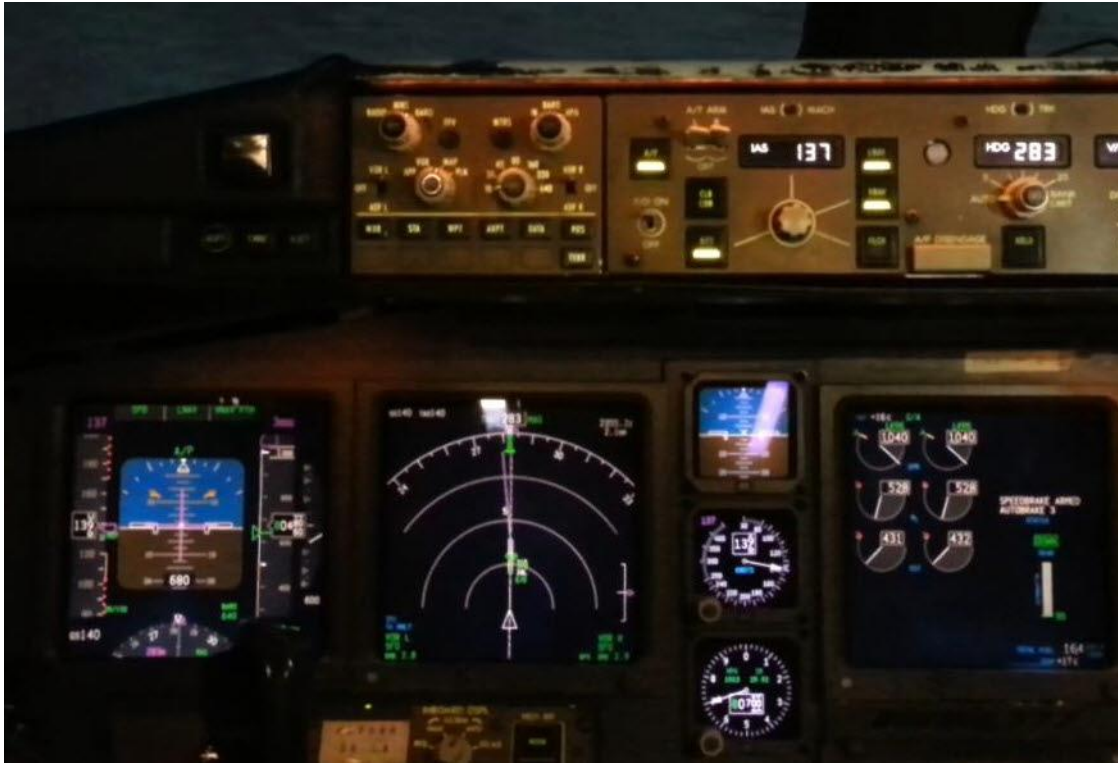
The usual ATC pattern of NorCal TRACON is to clear the aircraft for a visual approach and to maintain 180 kts until 5NM to SFO (*"Cleared for visual approach runway 28L, maintain 180kts until 5nm."* AM 1122 LOCAL Time excerpted from NTSB ATC Group Chairman's Field Notes Figure 6). The subsequent simulator testing has shown that maintaining 180 kts to 5 nm makes it difficult to complete the landing configuration and checklist before passing through 1000 feet for checklist completion. (See Figure 5)

Figure 5 - The following picture was taken during a simulator testing, showing the landing configuration (flap 30) and approach target speed (137 KT) completion around 680 feet while complying with the ATC instruction (180 KT, 5 NM)
